The last seconds

FLIGHT 1420

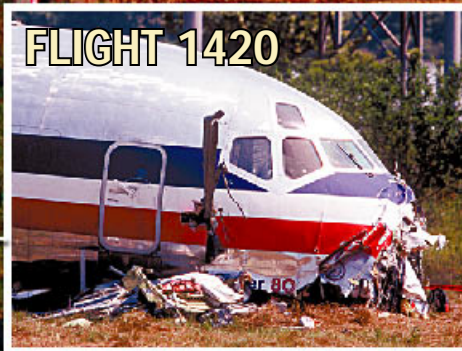
1 APPROACHING FROM THE SOUTH, American Flight 1420 touches down 11:51 p.m. Tuesday during a thunderstorm. It skids off the rain-slickened runway twice, first to its right and then (skid marks) to its left. Out of control, it veers across a taxiway and toward the Arkansas River.

4 THE AIRPLANE'S FIRST CONTACT with the steel stanchions supporting the walkway comes at midfuselage, directly in front of the wings. The collision rips off the left wing and breaks the plane's body in two.

5 IN TWO PIECES, the plane stops about 50 yards from the river's edge, lying in the muck between the river and the embankment.

2 ABOUT 450 FEET PAST THE END OF THE RUNWAY, skewing to its right, the airplane clips one end of a row of approach lights anchored in steel, but the plane sustains little damage.

3 THE PLANE THEN SAILS OVER a sloping 25-foot rock embankment, crushing a chain-link fence and tearing through a galvanized-steel walkway that extends into the river. The ruptured walkway rakes the left side of the airplane from the cockpit to the rear of the first-class cabin.
